Facilities Condition Assessment Report

Browns Mill Park | October 2018

5101 Browns Mill Rd, Lithonia, GA 30038

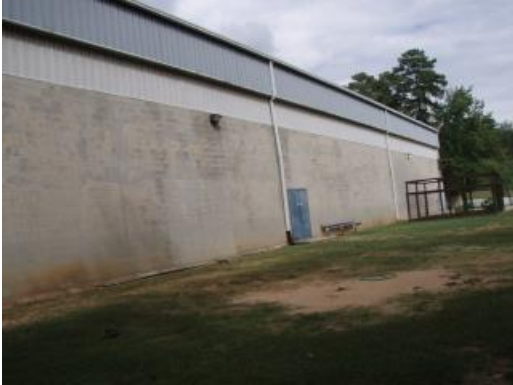
CMU Wall Requires Cleaning

Deficiency	Category	Qty	UoM	Priority	Repair Cost	ID
The Exterior Requires Cleaning Note: CMU Wall	Capital Renewal	6,848	SF Wall	5	\$12,857	2
The Exterior Requires Painting	Capital Renewal	1,554	SF Wall	5	\$8,625	3
Sub Total for System		2 items			\$21,482

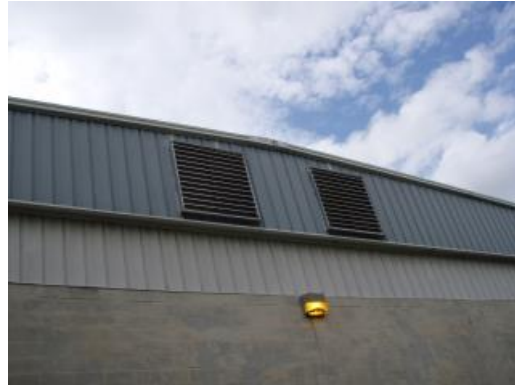
Rain Blows in During Storms

Deficiency	Category	Qty	UoM	Priority	Repair Cost	ID
Canopy Is Missing And Needed Note: 4 EA, 6 LF, OVER GYM EXHAUST FANS, RAINS BLOWS IN DURING STORMS Location: EAST AND WEST EXTERIORS	Capital Renewal	24	LF	4	\$11,858	4
Sub Total for System		1 items			\$11,858

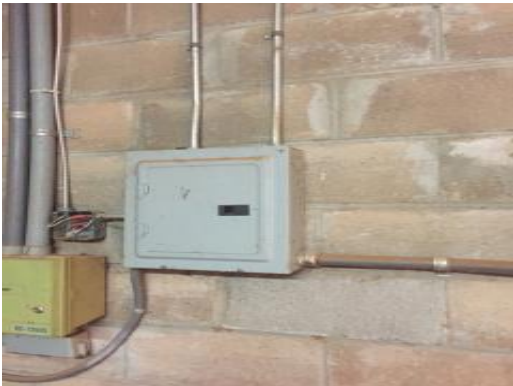
15 KVA Transformer

Deficiency	Category	Qty	UoM	Priority	Repair Cost	ID
The Electrical Transformer Requires Replacement Note: Transformer running hot Location: Store Room	Capital Renewal	1	Ea.	2	\$5,550	12
Sub Total for System		1	items		\$5,550	
Sub Total for Building 104 - Baseball Field House		2	items		\$6,114	
Total for Campus		14	items		\$111,275

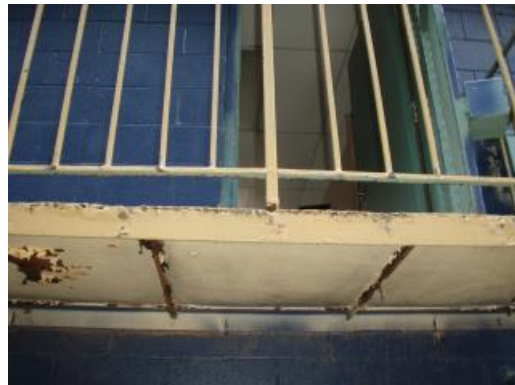
Replace Metal Stairs Located Rear of Building

Deficiency	Category	Qty	UoM	Priority	Repair Cost	ID
Replace Metal Staircase Note: On rear of building, corroded.	Capital Renewal	2	Ea.	3	\$21,229	6
The Exterior Soffit Requires Repair Note: At rear of building	Capital Renewal	20	SF	5	\$378	7
Sub Total for System		2	items		\$21,607	
Sub Total for Building 103 - Football Field House		3	items		\$45,747

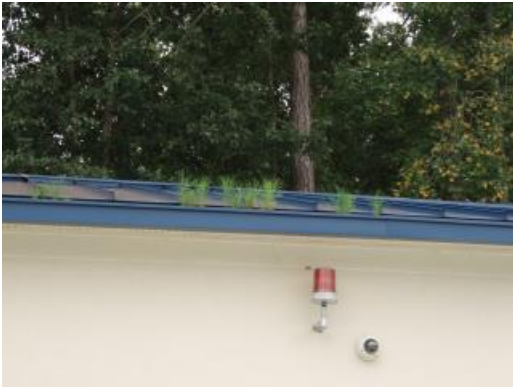
Gutter at Lazy River Pump Room

Deficiency	Category	Qty	UoM	Priority	Repair Cost	ID
Debris In Gutters Requires Removal Note: At Lazy River Pump Room	Capital Renewal	100	LF	3	\$619	5
Sub Total for System		1 items			\$619

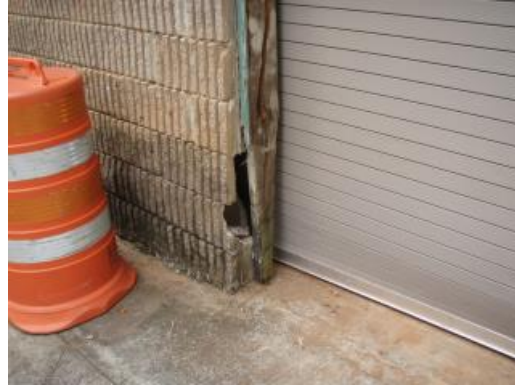
Repair CMU Wall

Deficiency	Category	Qty	UoM	Priority	Repair Cost	ID
The Concrete / CMU Exterior Requires Replacement	Capital Renewal	20	SF Wall	4	\$564	8
Sub Total for System		1	items		\$564

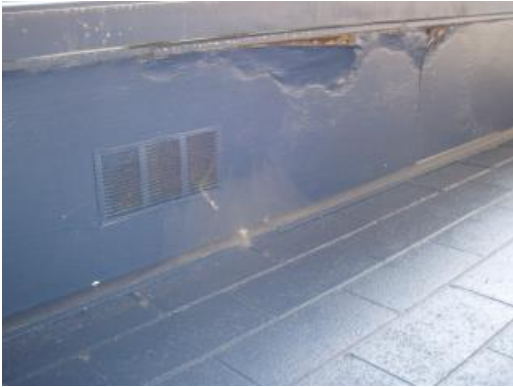
Soffit at Rear of Building

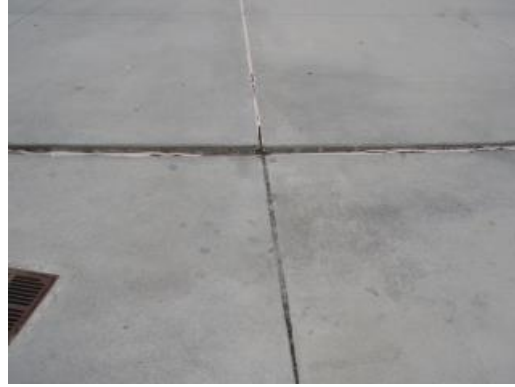
Uneven Surface Between Pools

Deficiency	Category	Qty	UoM	Priority	Repair Cost	ID
Concrete Walks Require Replacement Note: Uneven surface between pools.	Capital Renewal	90	SF	3	\$1,142	10
Fencing Requires Replacement (8' - 10' high Chain Link Fence) Note: Adjacent northeast gate, tree damage	Capital Renewal	20	LF	4	\$812	11
Sub Total for System		2 items			\$1,954	
Sub Total for School and Site Level		2 items			\$1,954

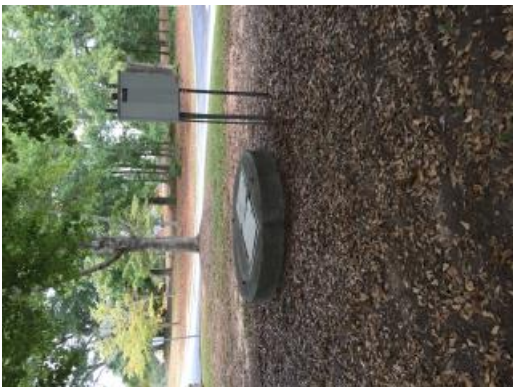
Sanitary lift station sump hatch is not secured. Sump is at least 20 feet deep.

Deficiency	Category	Qty	UoM	Priority	Repair Cost	ID
Repair/Replace Non-Standard Piping - Hydronic / Steam Note: Sanitary lift station sump hatch is not secured. Sump is at least 20 feet deep.	Functional Deficiency	1	Job	1	\$741	9
Sub Total for System		1 items			\$741	
Sub Total for Building 101 - Recreation Center		4 items			\$34,081

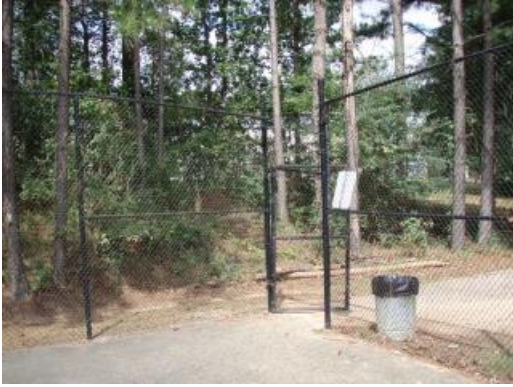
Adjacent Northeast Gate Damaged Tree
